Subject SATURN T.

Subject SATURN T

## BELOW DECK ELECTRONIC UNIT (BDEU)

## FUSES &amp; TEST POINTS, ADE

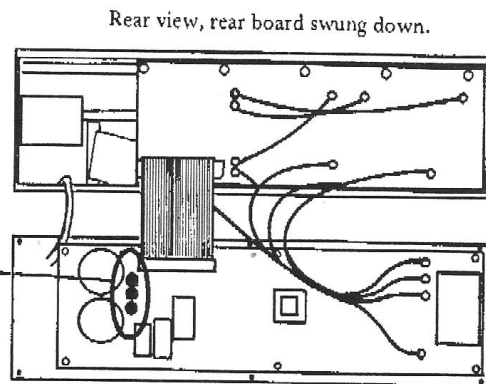
Defective fuse F3 only.

I am sure that blown fuses  
is the problem.

1.6 A Slow  
17 V

F2

4 A Slow  
5 V

F4

1 A Slow  
-20 V

F3

Mains fuse  
1 A Slow

Pls. check the fuses on the  
units in Eritrea.

*Mn. Testpage!*  
*Pls. check the fuses*
