Subject SATURN T.

Subject SATURN T

## BELOW DECK ELECTRONIC UNIT (BDEU)

## FUSES &amp; TEST POINTS, ADE

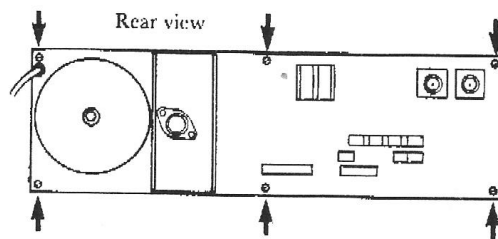
- a) defective fuse F3.
- b) defective telephony receiver.

Defective fuse F3 only.

Loosen the six screws "←" and swing down the rear board.

*Mn. Testpage!*  
*Pls. check the fuses*

F3
